EUROPEAN PATENT APPLICATION

⑲ Application number: 86830070.8

⑤④ Member for indicating clogging of the air intake filter, particularly for motor vehicle engines.

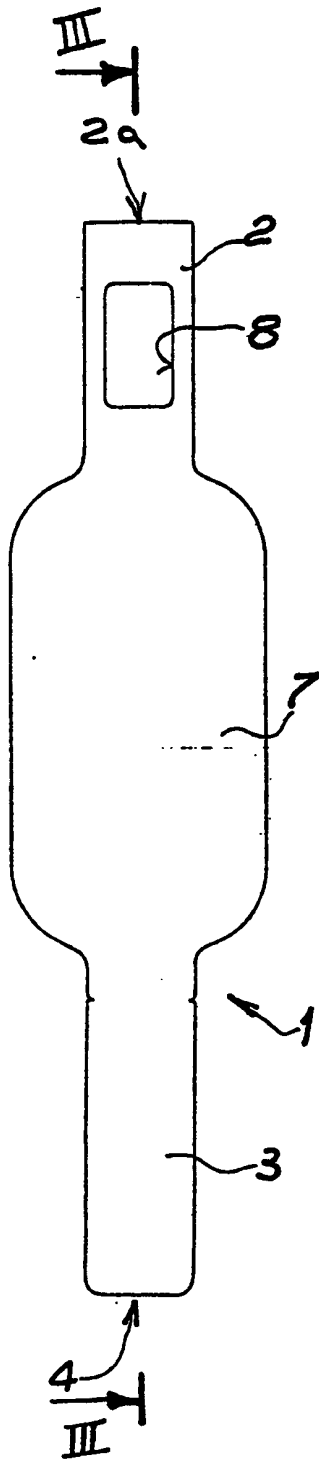
Fig. 1

Figure 1 is a plan view of the indicator member according to the
20 invention;

As can be seen from the figures, the indicator member according to the
30 invention consists of a duct 1 having an end portion 2 provided with an opening 2a to be located in communication with a zone external to the filter, and a tubular end portion 3 provided with an opening 4 communicating with the zone in which the air leaves the filter towards

A thin strip 6 of plastics material or the like is connected to this piston and extends through the intermediate portion 7 of the duct 1 as 10 far as the end portion 2. In proximity to the opening 2a of said end there is an aperture 8, through which the end part of the strip 6 can be seen.

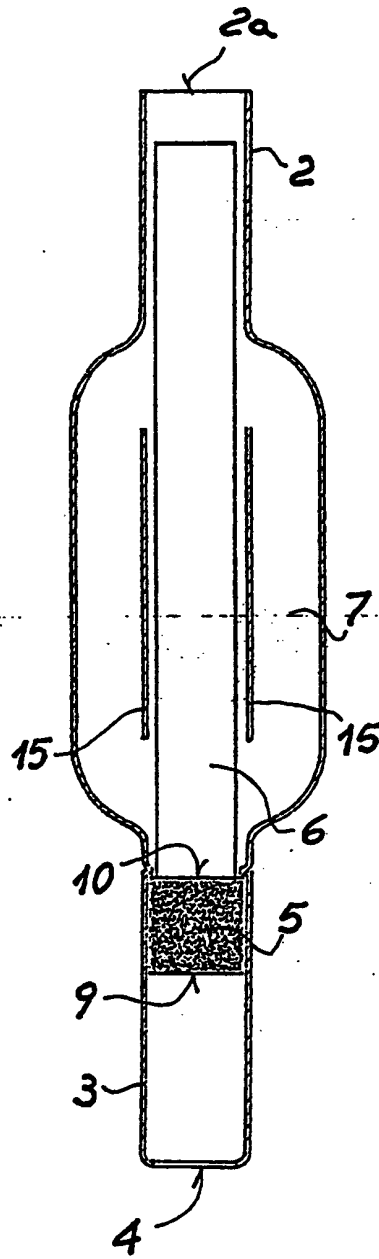
Fig. 2

Figure 2 shows the indicator member of Figure 1 without its upper part;

In the tubular end portion 3 there is disposed a piston 5 of light material such as expanded closed-cell material, which can slide within 5 the tubular portion 3 under the action of a slight pressure difference between the two parts of the tubular portion 3 separated by it.

Guide baffles 15 are conveniently provided in the intermediate portion 7 to help maintain the strip 6 aligned with the piston 5 connected to it, and to also provide rigidity to the portion 7 zone which is to be compressed for deforming said gaskets.

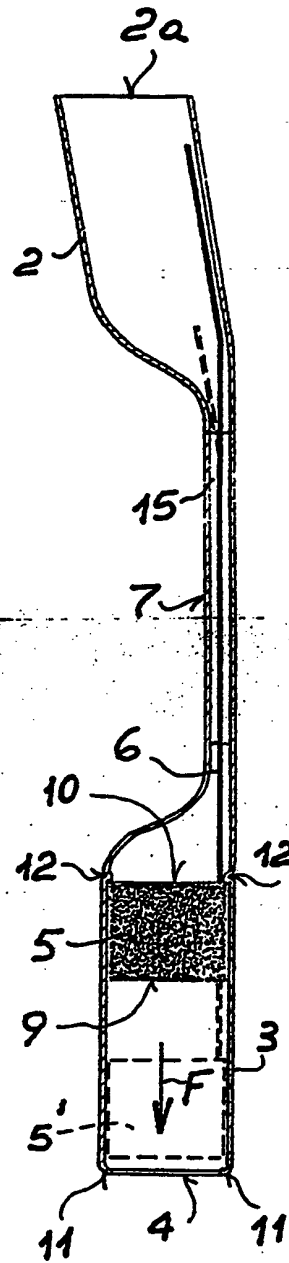
Fig. 3

Figure 3 is a section on the plane III-III of Figure 1; and

When the filter is clogged, the air drawn in by the engine undergoes a 20 large pressure drop in passing through the filter, and this results in a vacuum at the filter outlet in the direction of the engine. This vacuum also acts on the face 9 of the piston 5 which faces the end portion 3, whereas the pressure of the external environment acts on that face 10 of the piston which is in communication with the outside by way of the 25 intermediate portion 7 and the end portion 2 of the duct 1. Under these conditions, the piston thus moves in the direction indicated by the arrow F of Figure 3 to the position indicated by 5', in contact with the rim 11 at the opening 4 of the tubular end portion 3. The strip 6 is therefore no longer visible through the aperture 8, and this therefore 30 signals that the filter is clogged and requires replacement or cleaning.

When the filter has been replaced or cleaned, the piston 5 can be again moved into its initial position, indicated by the stop projections 12

provided internally on the end portion 3 in the position in which the end of the strip 6 is visible through the aperture 8.

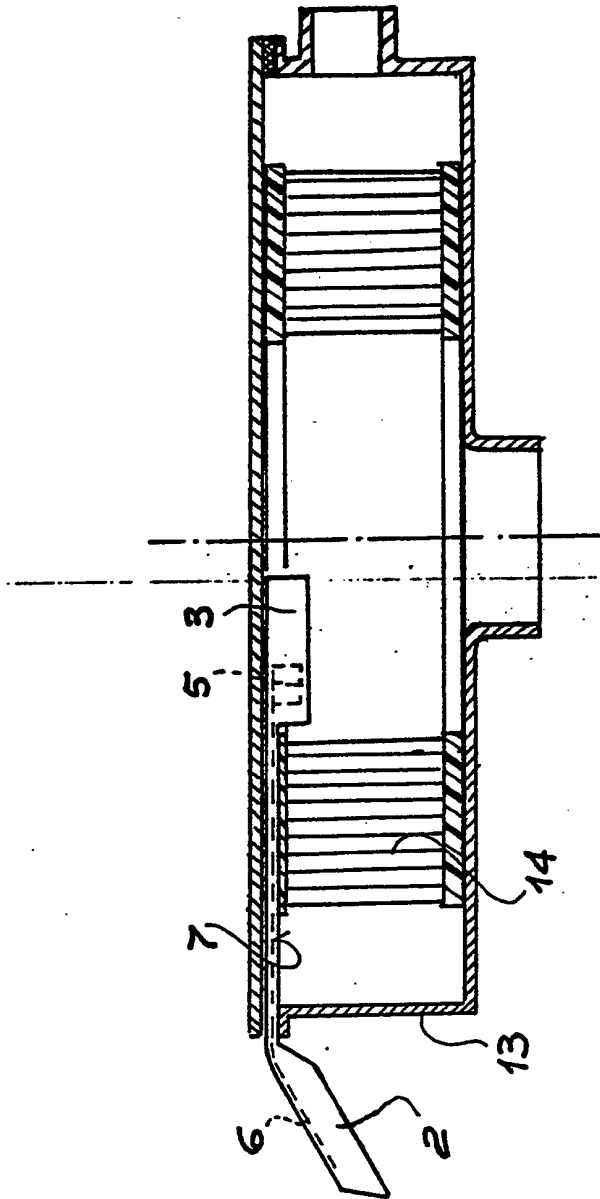
Fig. 4

Figure 4 is a diagrammatic section through a filter provided with the indicator member according to the invention.

As can be seen in Figure 4, the indicator member according to the invention can be mounted in a filter casing 13, and disposed with its intermediate portion 7 over the annular filter 14. The tubular portion 3 thus lies in the inner zone of the filter, in communication with the engine intake duct, and the end portion 2 lies external to the casing 13, enabling the aperture 8 to be seen without dismantling the filter casing.

This is attained by a slight deformation of the seal gaskets of the casing 13 and filter 14, the intermediate portion 7 being constructed with a very small thickness, which is less than the deformability of said gaskets.

The intermediate portion 7 is wider than the remaining parts of the duct 1, to provide in the zone corresponding with said small thickness an intake air passage area large enough to give sufficient indication sensitivity by limiting the pressure drop.
